**North Slope of Alaska ARM Facilities  
Monthly Status Update  
Sandia National Labs**

**August 2017**

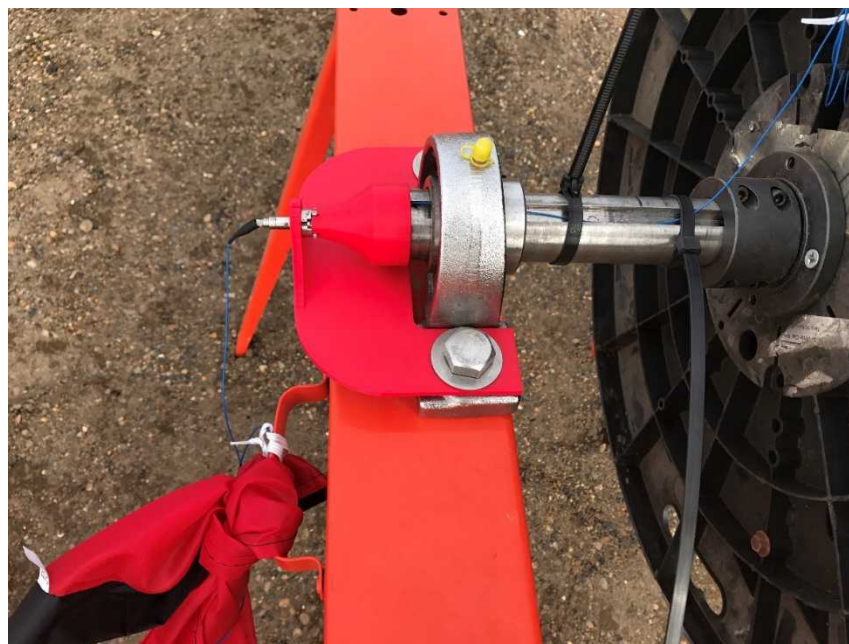
Figure 7: Fiber optic rotary joint installed on motorized fiber reel for DTS

Comparisons from 08/04/17 TBS DTS through the radiosonde joint appeared to compare well. There is some excess heat in the lowest 150m of the fiber trace due to friction within the rotary joint as it spins.

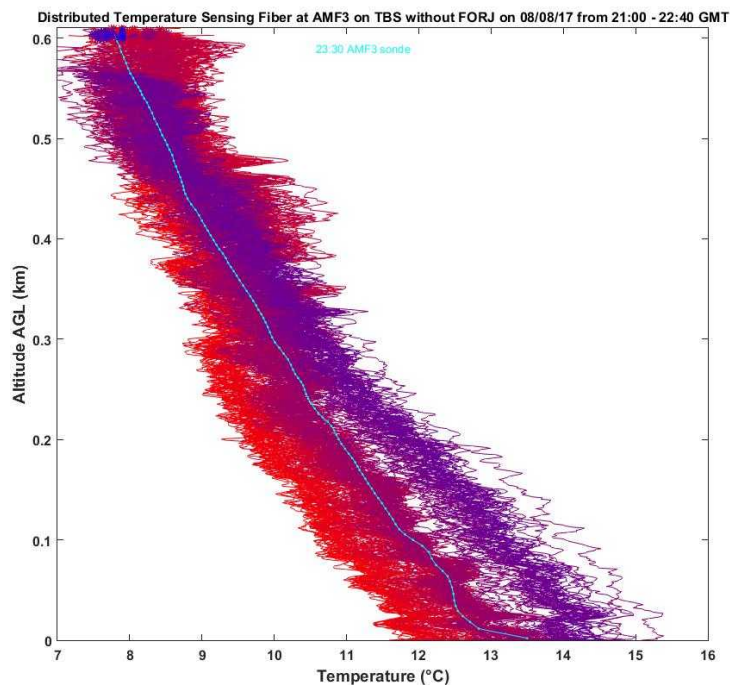
Figure 14: DTS without rotary joint on TBS on 08/08/17

- We intended to fly Flight 1 with DTS fiber not using the rotary joint, and Flight 2 with fiber using the joint. Upon preparation for flight we determined that the two fiber reels we intended to use were spooled so that only one fiber end was left exposed. To fly on the balloon we need both ends of the fiber to be exposed on the spool. We will have to spool these two fibers onto new spools in order to access both ends.

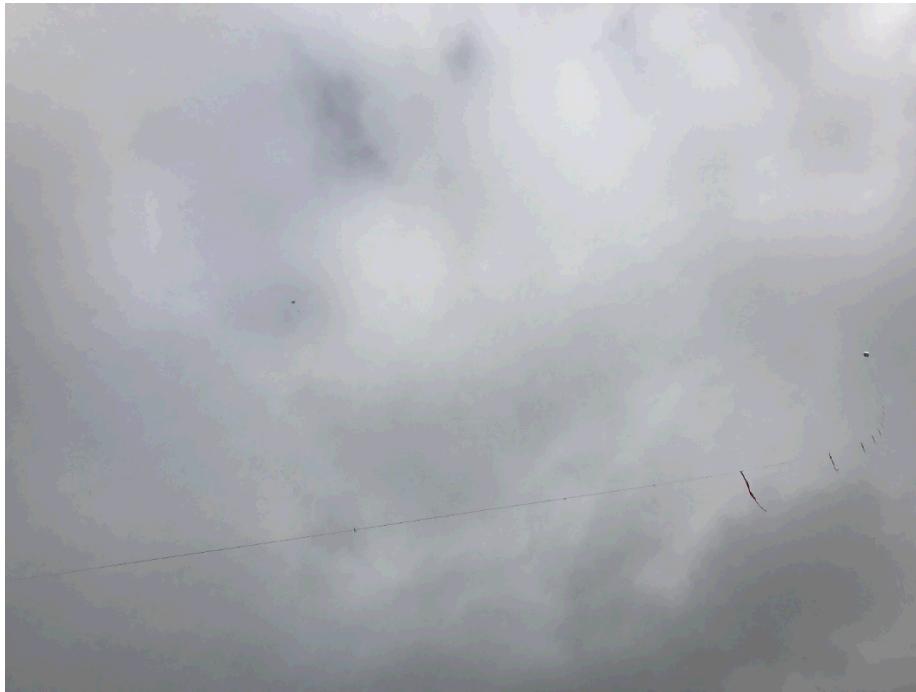
Figure 19: Octocopter and helikite in flight at 400m at Sandia site on 08/09/17 during JUBA

Ascended balloon to 530m while ascent filmed from octocopter loitering aloft. Winds were fairly high, 7 m/s, and shortly after launch it appeared that the DTS fiber had a break about 200m from the surface. On the fifteen-minute flight one of the octocopter, the fiber ripped from the UAS on the descent in high winds. 30s integration time DTS data was collected until approximately 50m AGL on the descent. Flight two was a fifteen-minute flight also, but was completed successfully. Lower clouds moved in limiting the octocopter to < 200m AGL so flights were postponed for a few hours, after a test flight to determine visibility (flight three). Flight four used a 15s integration time on the DTS and a sounding balloon was launched for comparison. Again on the descent the fiber ripped at approximately 50m AGL. After landing it was determined that there was a large burr inside the tubing that the fiber was passing through on the surface.

Unfortunately the TBS DTS fiber suspended on the helikite for comparison purposes with the octocopter DTS broke shortly after launch. Again, when compared to the sounding the DTS below the octocopter was too warm, likely due to being run through a heat tray at the surface in order to identify the surface.

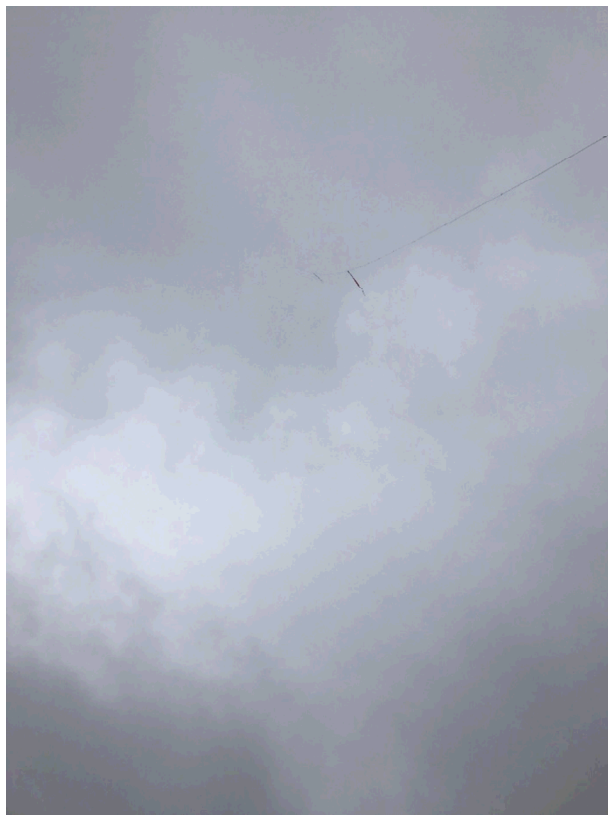
Figure 26: Tether into clouds at 23:10 during Flight 4

Several iMet temperature probe wires were broken by semi-solid precip during Flights 3 and 4, as well as DTS fiber splice, and apparent possible short-term plug of POPS SN14 inlet. iMet temperature wire probes may be endangered during future October flights.
